Deepwater Oil Spill - Top Kill Update, Restarting the Mud, and Comment Thread

Posted by [Heading Out](#) on May 28, 2010 - 7:28am

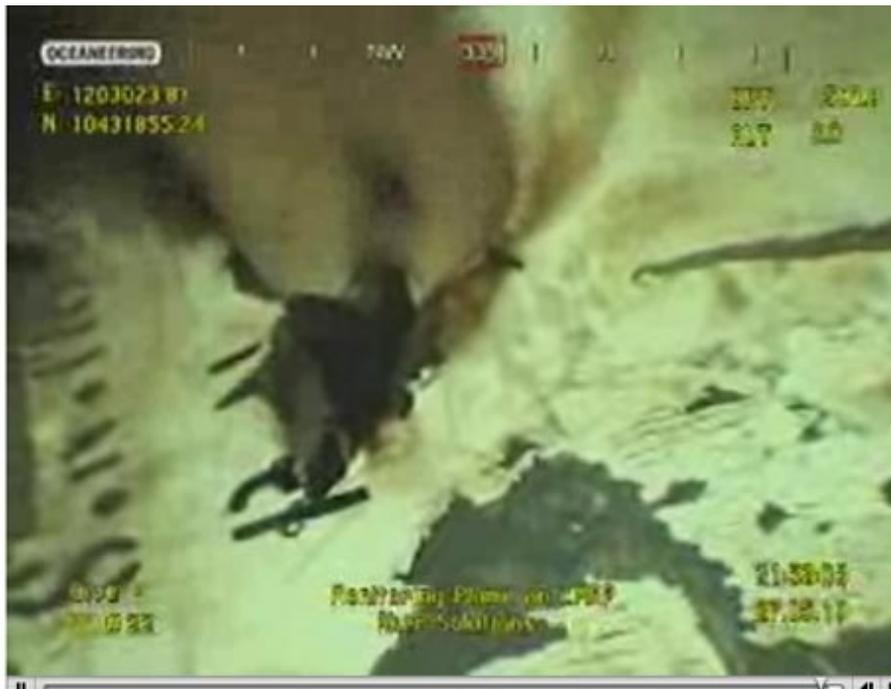
9:52 pm the camera is focusing on the cracks in the riser, and it seems that they may be injecting rubber pieces one of which is now stuck in one of the cracks in the riser. (Not very securely it seems)

Piece of "junk" (?) in the riser crack, as BP apparently work to reduce the size of the path through the BOP.

Note that this piece has had to pass through the BOP, and it is sealing the BOP path which is more critical to success. It could also be a piece of the rubber from the annulus seal that broke loose and got caught in the riser. Without knowledge of what BP is trying it is hard to decide, but the flow looks to be still gas and oil without mud, and I would expect that BP would have to use mud as the

carrier if they were injecting material into the flow, so this could just be a piece of seal that got caught. If you can't tell where it is, it is in the crack to the immediate right of the center line (without the paint) on the riser. (The view has changed)

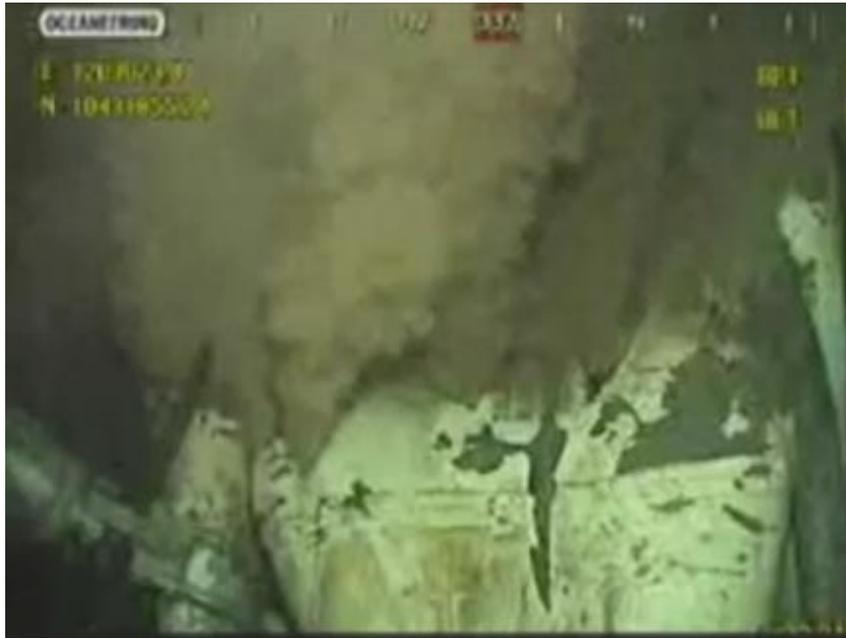
Leak shot at 10:25 pm Central

UPDATE 1: Mud is clearly visible in the change in the look of the flows out of the riser. But at the moment it does not appear to be under the pressure of the flows on Wednesday. (This could be because it is being pumped in at a lower pressure, or it could be that they have sealed some of the leaks in the BOP and that is cutting back the driving pressure at the riser).

The problem we saw on Wednesday night with mud being heavier than oil and thus settling more readily and obscuring the view, is also evident.

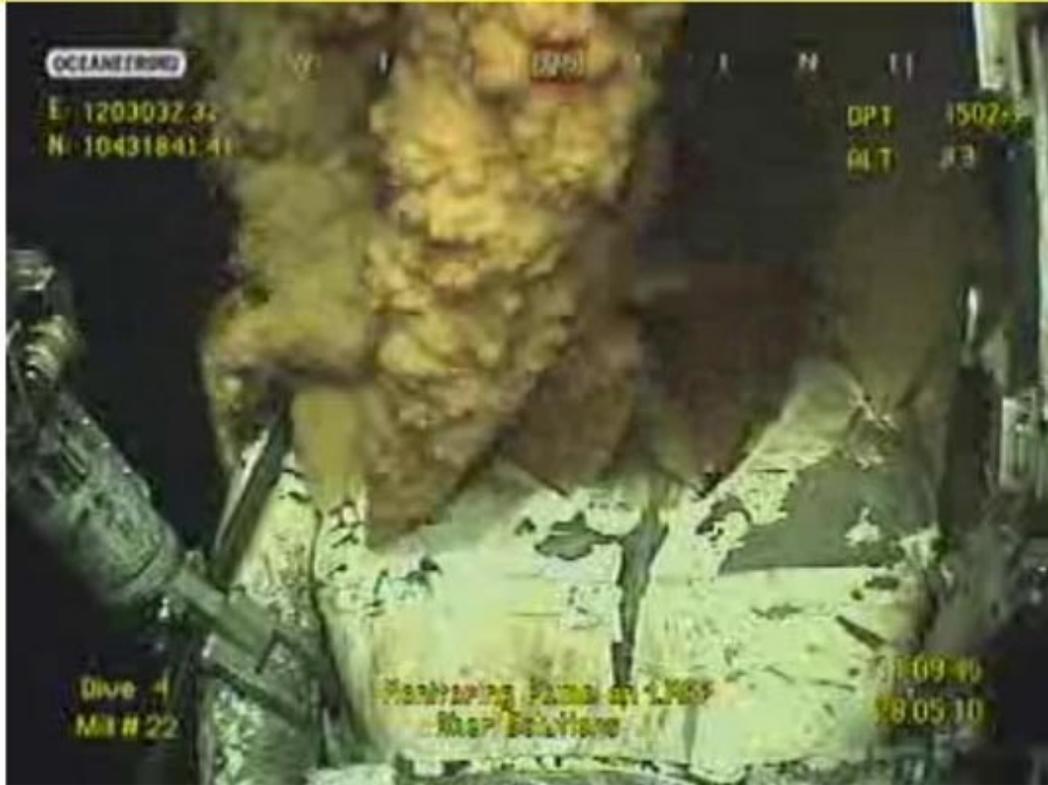
Flow at 11:09 am

UPDATE 5: 11:09 AM The feed has gone back to the riser, and we are back to the oil and gas flows that we were saw at the beginning. Not quite the same shapes as earlier, so perhaps the block in the BOP was partially effective, but BP have now apparently filled the well twice and failed to get enough weight into the mud to hold the driving pressure from the rock. They could try again with a higher density mud, I am presuming that the second shot had a higher weight than the first, and that while the first left a small pressure imbalance, that the second was closer, but as yet no banana. (Though the Admiral did say that they had stabilized the flow). My presumption is that they will mix up another batch and try again - though whether they will try
