BP's Deepwater Oil Spill - Relief Well Intersection Version 2 and Open Thread

Posted by Heading Out on August 11, 2010 - 10:32am Topic: Environment/Sustainability Tags: deepwater horizon, oil spill [list all tags]

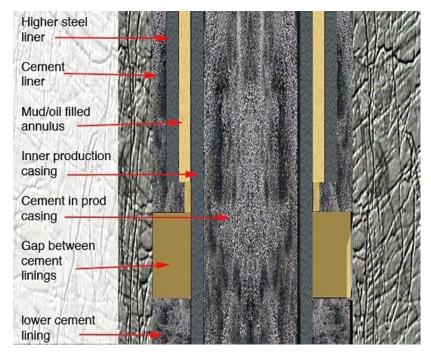
So that if I go back to the original situation at the intended intersection point, what it may well look like at the moment is this:

The vertical gap between the two outer cement linings which (for simplicity) I have shown as very short is actually likely to be a couple of hundred feet long perhaps. The inner cement plug within the production casing stretches several thousand feet above the intersection point.

The bottom of the well is some 800 feet further down the production casing. At the present time the well is being held at 4,200 psi pressure at the BOP to check and see if there are any leaks. Just as an observation when you put that much pressure on that long a solid confined column it will dissipate out to side loading long before it gets down to this depth, so the test does not have that much value in these particular circumstances. As far as testing the integrity of the central cement plug, neither will the negative pressure test which they intend to follow the current positive pressure test with. In this case they will lower the pressure in the well to 2,300 to 3,000 psi, and see if the well makes fluid. Again, because of the length of the cement column in the production casing, that drop in pressure will not extend down to the intersection point (let alone the bottom of the well) and thus won't provide that much information on the conditions at the reservoir.

What it will do, however, is provide some information about what might be going on in the annulus and particularly what might be in the gap, and the condition of it before the relief well runs into it. If the integrity of the production casing remains, (except potentially at the bottom of the well) and all the mud and cement flowed down it, and into the formation, then there may be no way for the fluids in this annulus to have escaped the well. (I have colored them an off yellow since we don't know if they are oil or mud.) If they are the original drilling mud, and the lower cement lining around the production casing has retained enough integrity to seal this zone off from the bottom of the well and the reservoir, then this may even still be the mud used just prior to the cementing of the production casing.
